# Distortion-induced fatigue cracking at lateral gusset plate details /

David C. Wagner  
*Lehigh University*

A Thesis  
Presented to the Graduate Committee  
of Lehigh University  
in Candidacy for the Degree of  
Master of Science  
in  
Civil Engineering

May 1987

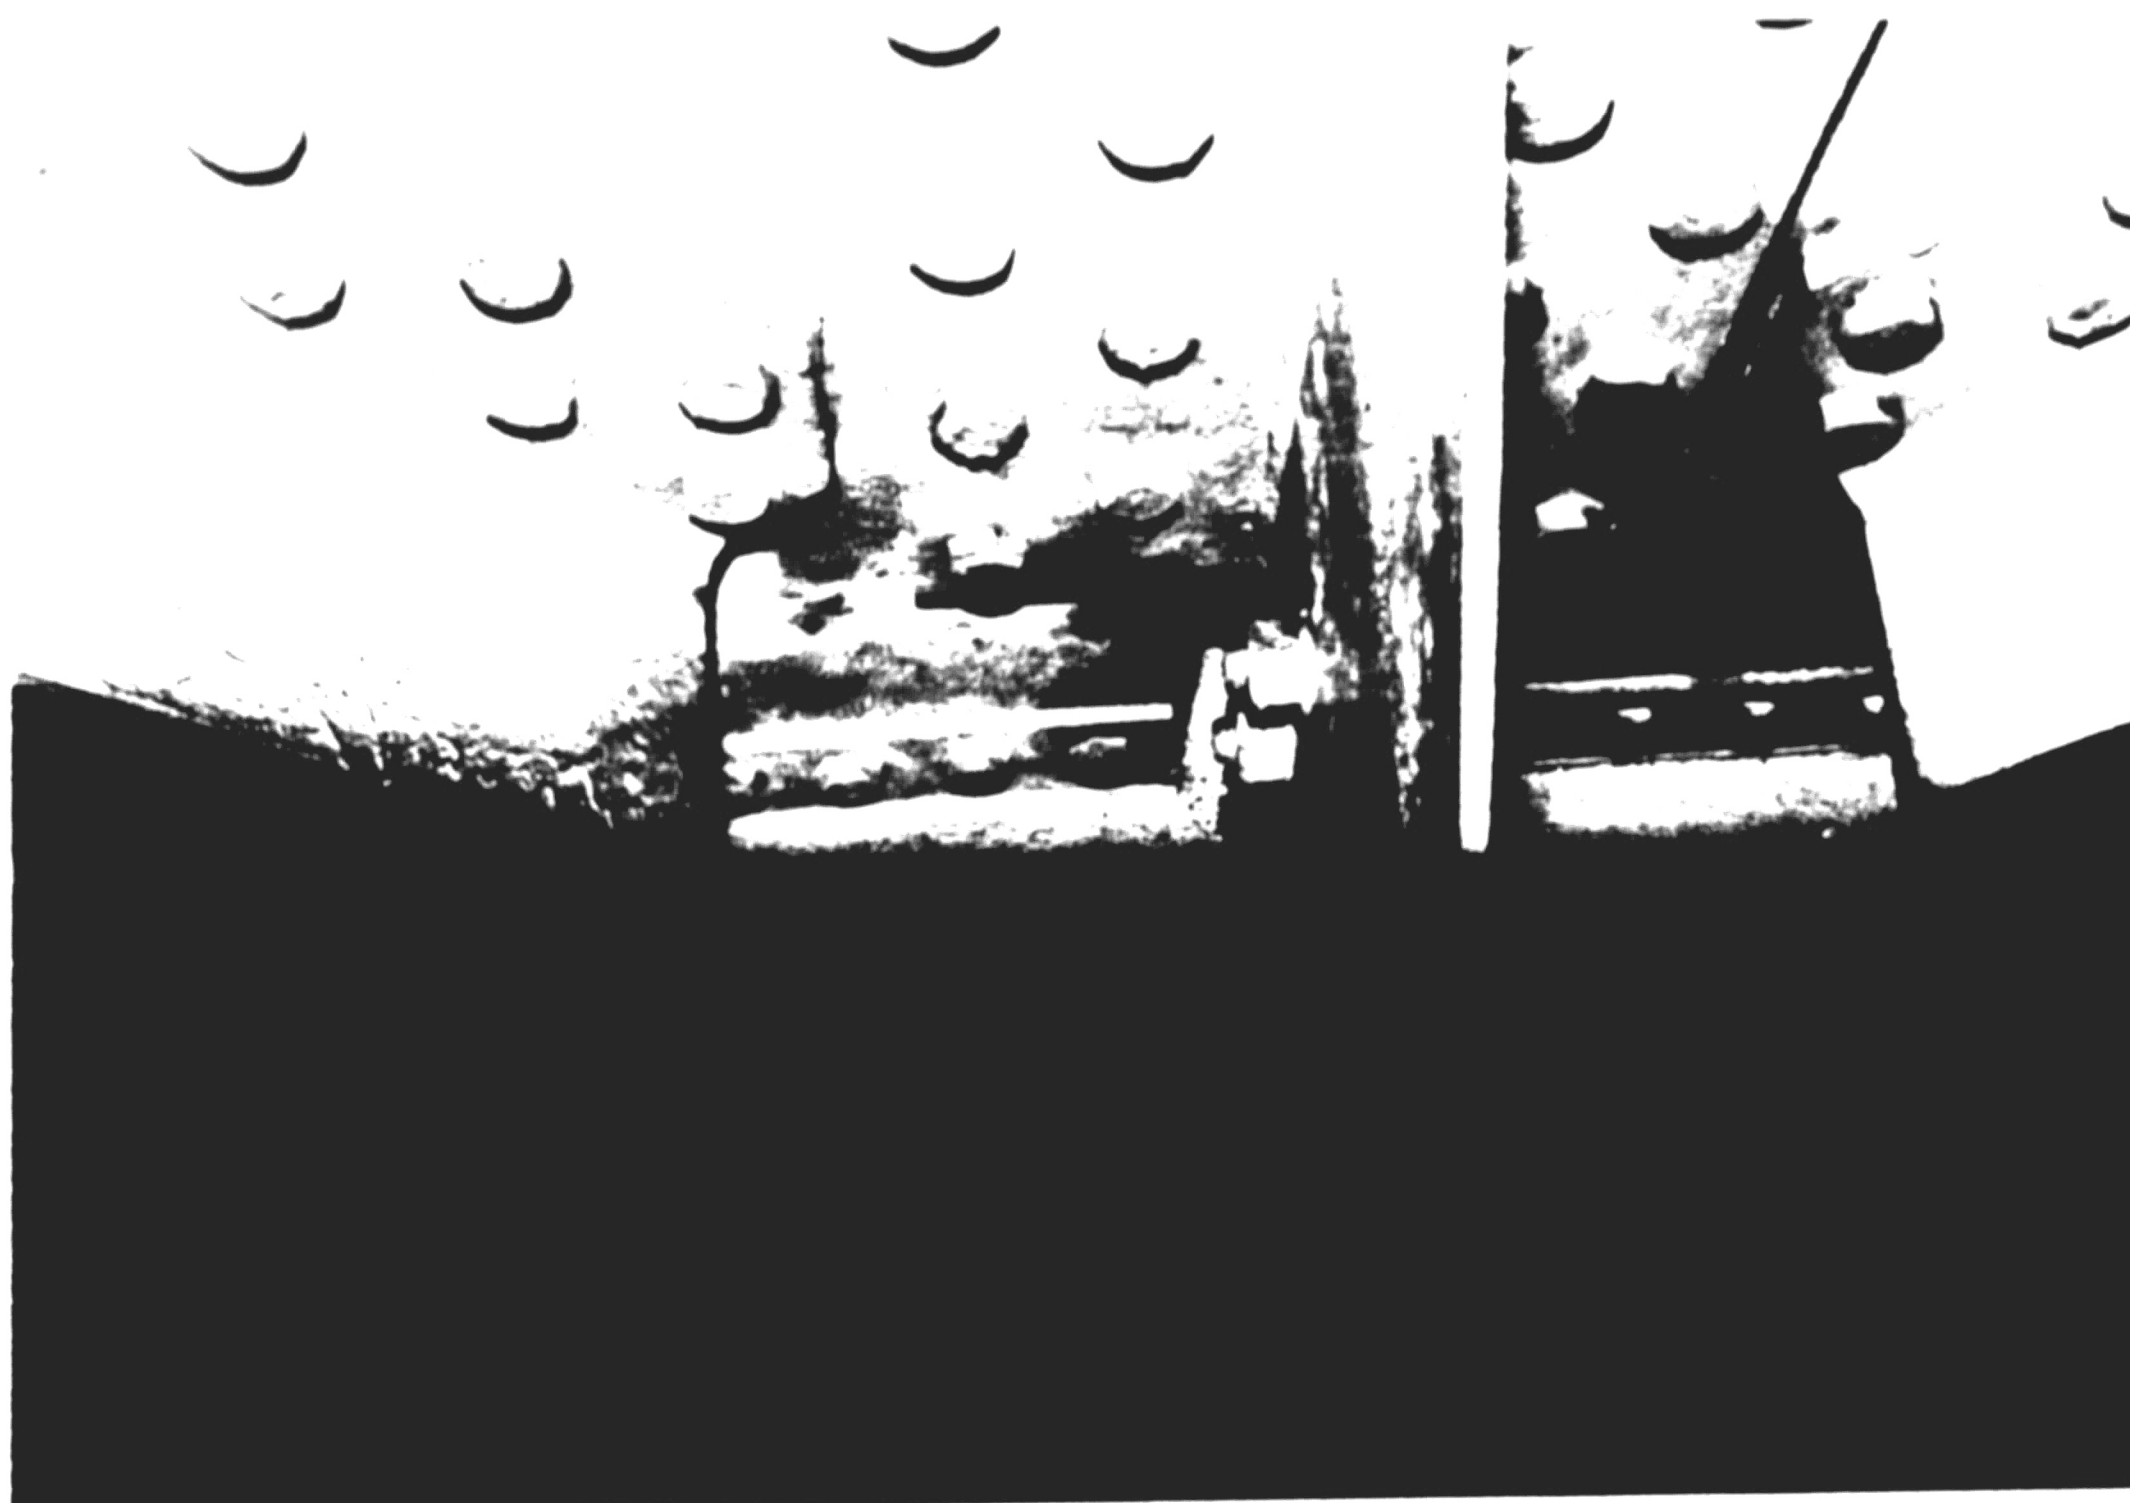
**Figure 4:** Canoe Creek Bridge Lateral Gusset Plate Detail

The laterals (ST7WF39) are connected to both the floor beam and the girder web through two gusset plates of 0.375 in. (9.5 mm) thickness. Inspection of the plate attachment, shown in Figure 4, revealed three types of fatigue crack indications. The first, shown in Figure 5, prevailed at the weld toe of the outer end of the gusset plate tabs. The second occurred in the small horizontal web gaps between the transverse connection plate and the gusset plate tabs. This mode of fatigue cracking is shown in Figure 6. The third type of crack indication was related to the horizontal web gap, but occurred on the outside surface of the girder web along the vertical stiffener as shown in Figure 7. These crack indications were observed on each side of the vertical stiffener at the level of the lateral gusset plates at most floor beam locations in both the negative and positive moment regions.

The existence of the second and third types of cracks was not expected. Referring again to Figure 4, the gusset plates are bolted to the bottom flange of the floor beam as well as the two horizontal connection plate tabs which are in turn welded to the girder web. The fabricated joint has a high degree of restraint, and no evidence of slip was detected at the bolts. The out-of-plane displacements necessary to induce secondary stresses above the detail's fatigue limit were not thought likely to develop within a connection of this type. Thus, even in the presence of positive attachment, local distortion has elevated the magnitude of the membrane stresses and contributed to the cyclic growth of fatigue cracks.

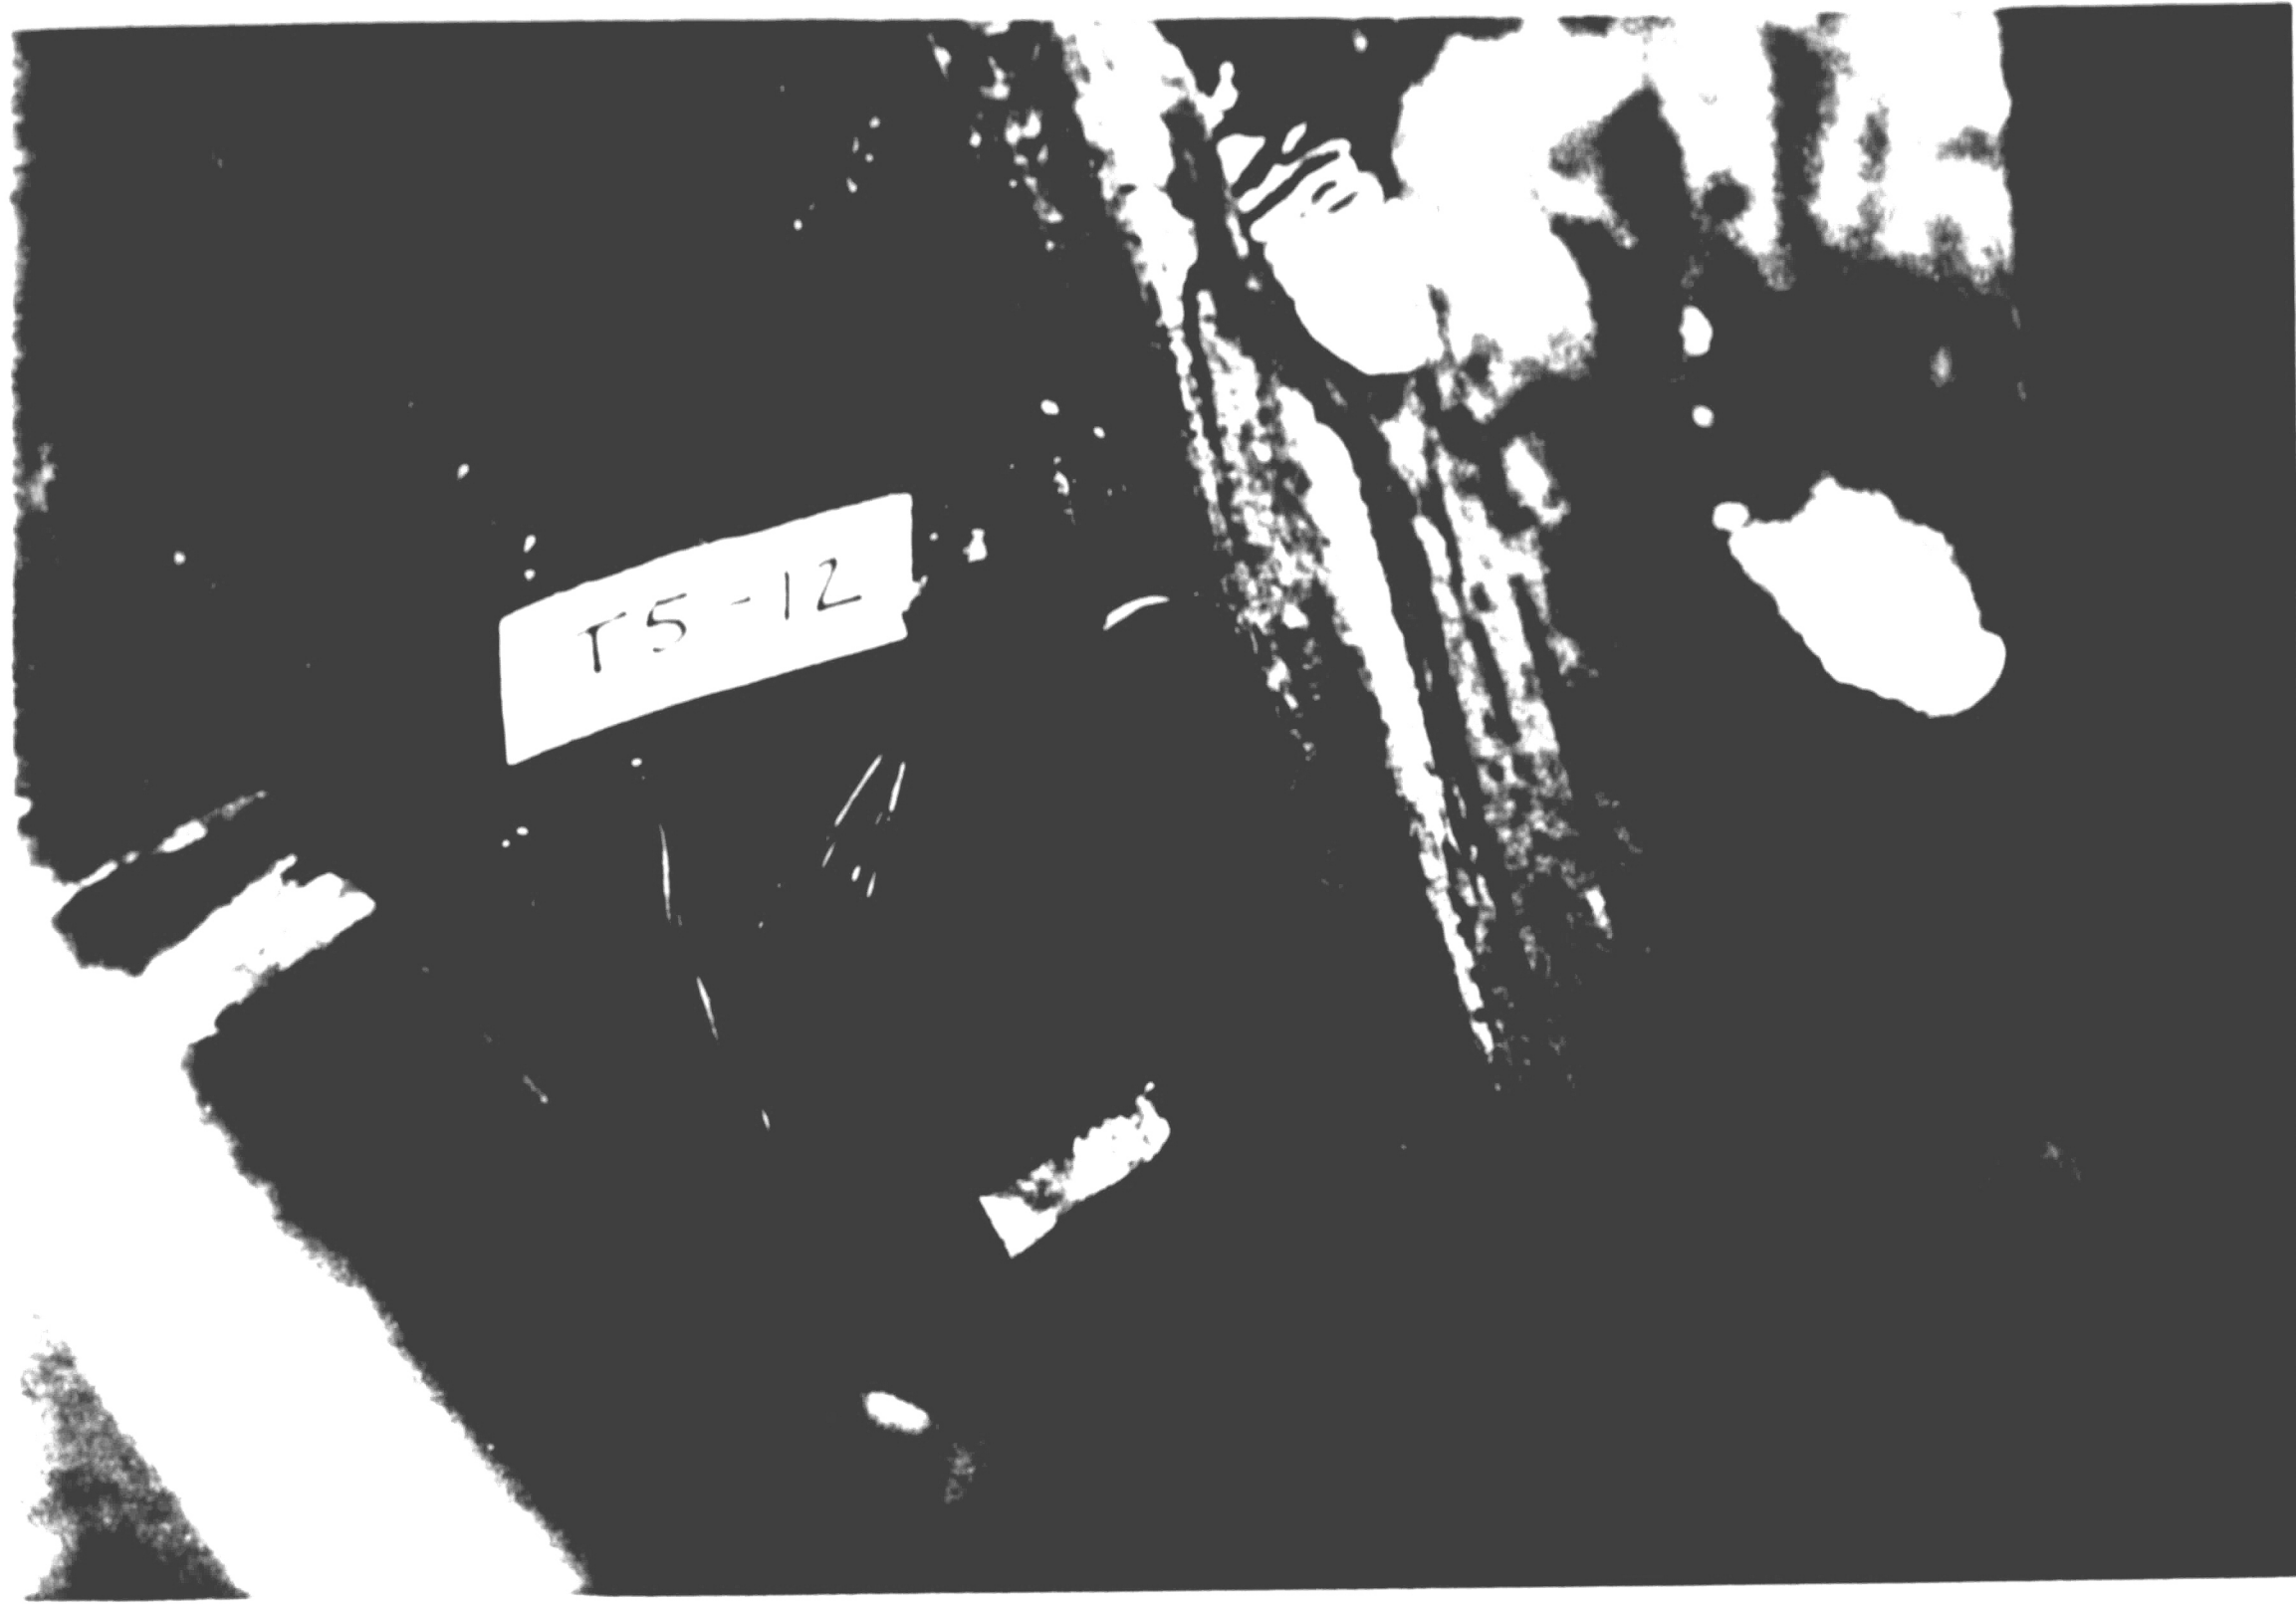
Figure 54: Cracking at Weld Toe Within the Horizontal Web Gap
